# Using thermal imaging to troubleshoot motors and drives

By Sat Sandhu

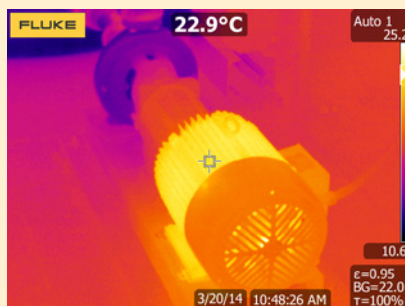
**Combo:** This heat pattern indicates an operational motor.
